Manhole Inspection Summary

Manhole # S09MM1033MH

Insp Date: **5/16/07 11:06 AM**

Location Address: **3345 EDGEMERE AVE**

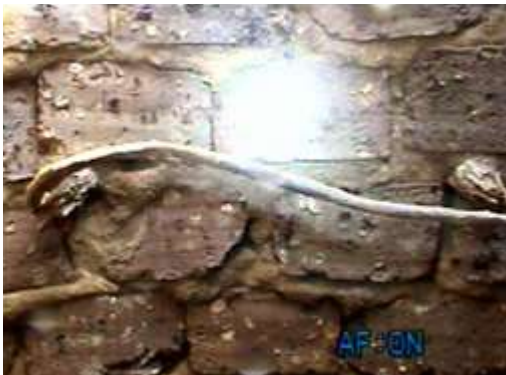
Defect 1

Count: **6** Missing: **0** ☒ **Corroded**

☒ **Evidence Of Surcharge** Depth: **4.5** (ft.) ☐ Active Surcharge Present

CORRODED RUNG AND EVIDENCE OF ASUR

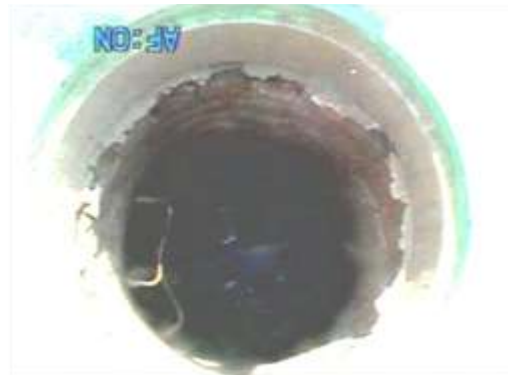
Defect 2

Condition: ☐ Sound ☐ Cracked ☐ Root Intrusion ☒ **Loose Brick** ☒ **Deteriorated**

CHIMNEY LOOSE BRICKS AND DETERIORATED

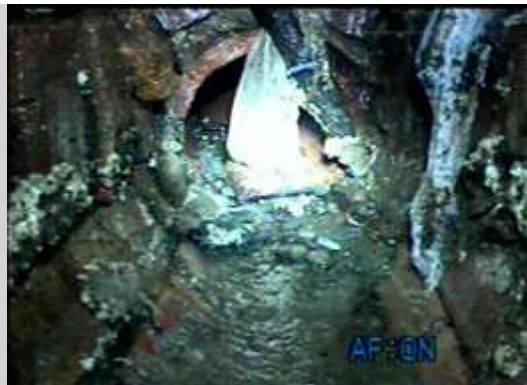
3 O'Clock Inflow

Pipe Height: (in.) Direct
Pipe Material: **Clay** ☐ Pipe Lined
Invert Depth: **11.54** (ft.) Flow Characteristics: **Slow**
Deposits: ☐ None ☐ Mud ☐ Sludge ☒ Debris ☒ Grease
Silt Depth: **8** (in.) Deposits Extent: **Heavy**
Infiltration: **Dripper** Pipe Seal Cond: **Broken**

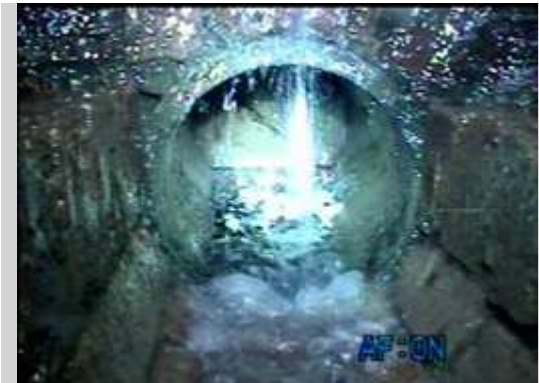
Drop In @ 9 O'Clock

Drop: **Outside Direct**

Drop Condition: **Clogged**
